## Case Study

# ENTRAPMENT OF A GUIDE WIRE: AN INCIDENTAL COMPLICATION OF CENTRAL LINE CATHETER PLACEMENT

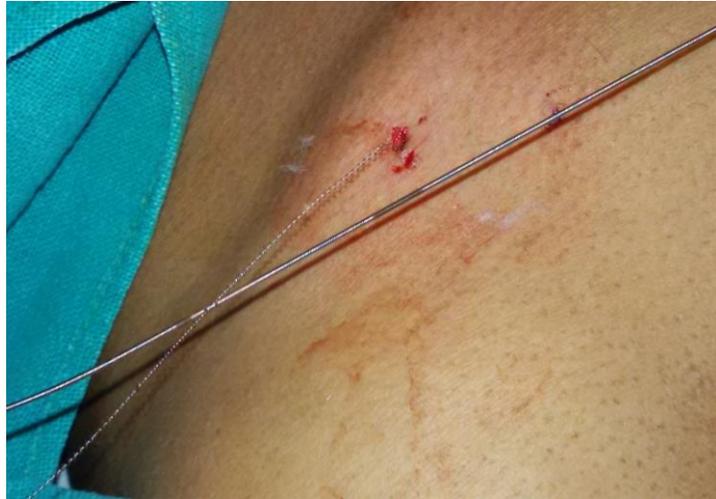
**Figure 1:**

After aspiration of blood, guide wire was introduced, but it could not be introduced more than ten centimeters. Thus, we tried to remove the guide wire, to reconfirm the backflow of blood in the introducer needle. But guide wire was stuck near its tip and many attempts to remove it with gentle traction failed. During this traction the introducer needle slipped and only the guide wire was left in place, which stretched out to the extent that it may break with further traction [Figure- 1]. We immediately shifted the patient to the operation theatre and got a C-Arm image done, which revealed that only J-tip of guide wire was entrapped and a knot was formed [Figure-2]. Immediately surgeons were informed and they widened the puncture site with nick and after doing some fine dissection guide wire came out with gentle traction [Figure-3]. After removal of guide wire local pressure was applied. USG was done to reveal any vascular injury or local haematoma.
