End cap missing the proximal end of the tibial interlocking nail to migrate posteriorly into the medullary canal: A complication that may be avoided

Keywords: Tibial interlocking, End cap, Migration.

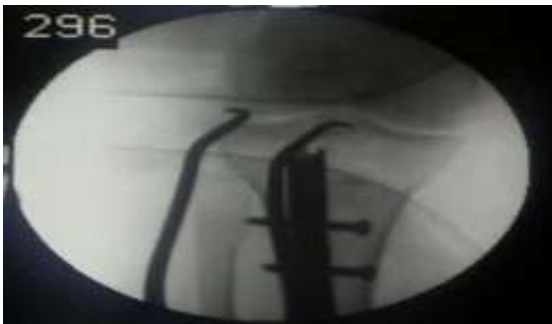
In the above mentioned case; the Nail, Guide wire and the End cap were all well aligned on the antero-posterior view but on insertion, the end cap missed the nail to sink in the medullary canal posterior to the nail (Fig. 1).

Fig. 1: Anteroposterior view showing the end cap having missed the nail head

End cap sinking posteriorly into the proximal intra-osseous redundant space behind the nail is a potential complication, which may be avoided by using a fixed position of knee flexion during reaming and nail insertion. Though cannulated end cap systems self-facilitate insertion, it would still be prudent that the position of the guide wire be confirmed on both the antero-posterior and the lateral radiographs of the proximal tibia before end cap insertion.

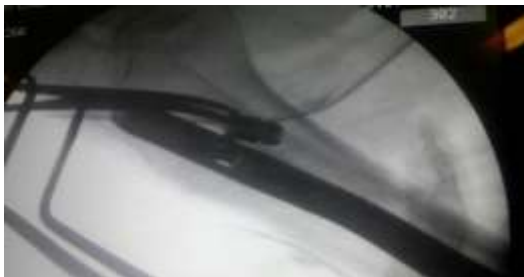
Fig. 2: Use of a curved hemostatic forceps inserted through the nail entry point for the retrieval of End cap from the posterior medullary canal

For the retrieval of the end cap from the canal a haemostatic forceps was used. (Fig. 2).

A “fish hook technique” using a bent k-wire, may also be used for misplaced end cap extraction.¹⁰
