## Esthetic rehabilitation of malpositioned implants – A case report

Aanchal Punjabi<sup>1\*</sup>, Gaurang Mistry<sup>2</sup>, Rajeev Singh<sup>3</sup>

<sup>1</sup>Post Graduate Student, <sup>2</sup>Professor and HOD, <sup>3</sup>Professor, Dept. of Prosthodontics, DY Patil University, School of Dentistry, Maharashtra, India

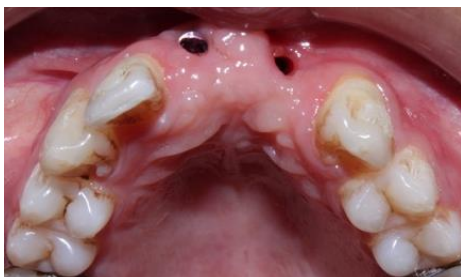
**Fig. 1a:** Intra-oral pre-treatment frontal view

On further examination, the implants were osseointegrated with a severe labio-palatal angulation, increased subcrestal depth (5mm in the 21 region) and compromised position. Hence the patient was given the following treatment options:

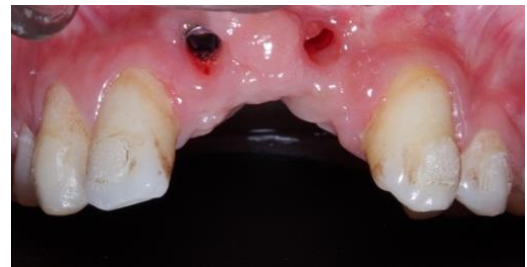
**Fig. 1b:** Intra-oral pre-treatment occlusal view

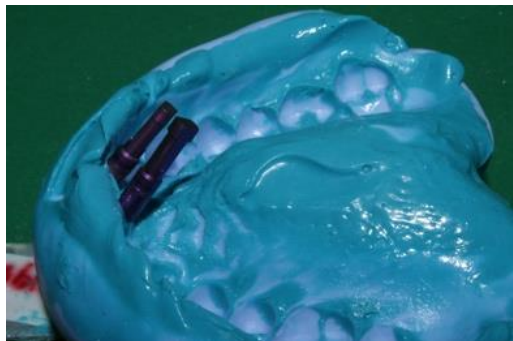
Fig. 2: Implant level impression

A closed tray implant level impression was made with addition silicone impression material (Aquasil; Dentsply); the accuracy of which was clarified with the aid of a verification jig. The model was then scanned using an extra-oral scanner and a computer aided designing of the prosthetic framework along with the final prosthesis was done on the Exocad software. At this stage it was observed that the adjacent teeth (12, 23) required laminates for establishment of satisfactory proportions and shape correction as the canine had to be converted into a lateral incisor.

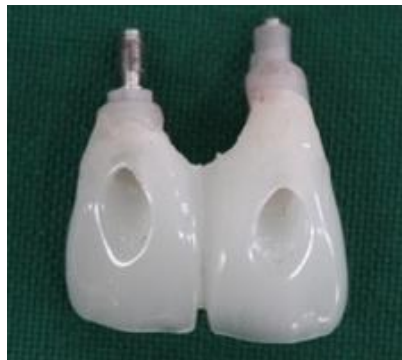
Fig. 6: Polymethyl methacrylate trial

On approval of the design, a polymethyl methacrylate trial was 3D printed and checked intra-orally for any modifications. Care was taken to ensure a correct angulation of the abutments along the contour of the maxillary arch in addition to a satisfactory level of the gingival zeniths and extra-oral lip support.

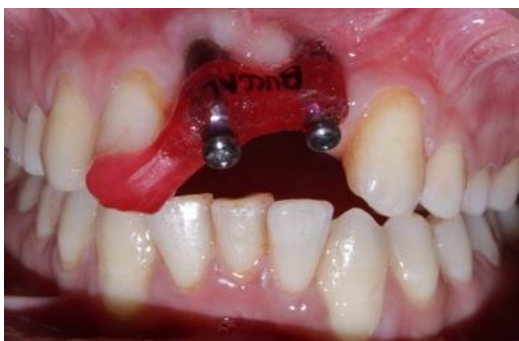
Fig. 3: Trial of verification jig

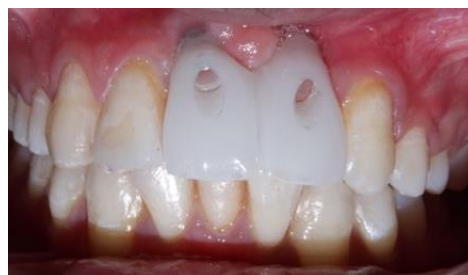
Fig. 7: Intra-oral trial of polymethyl methacrylate crowns

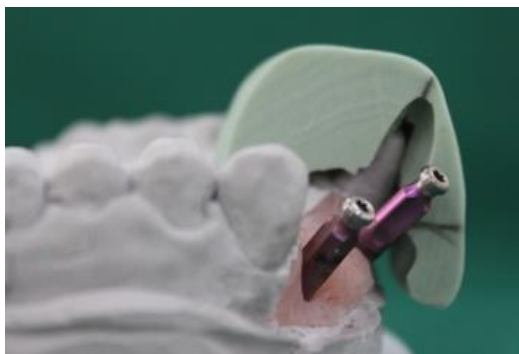
Fig. 4: Buccally tilted implant angulation. Note – correct tooth angulation depicted by the putty index.

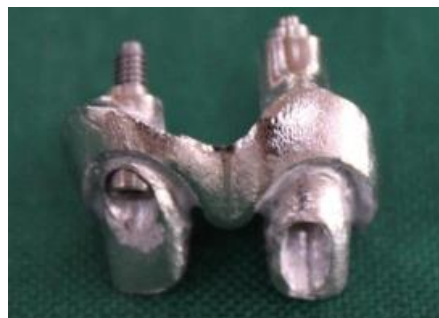
Fig. 8: Definitive titanium framework

Once the alterations were made, the screw-retained, definitive titanium framework was milled using computer aided manufacturing and verified intra-orally. Subsequently, the gingival aspect of the framework was layered with pink ceramic in addition to application of an opaquer over the abutments.

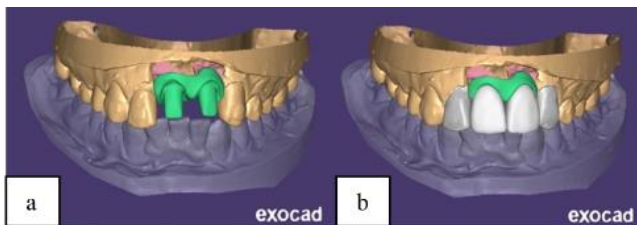
Fig. 5a, 5b: Computer aided design of prosthetic framework, final crowns and laminates.

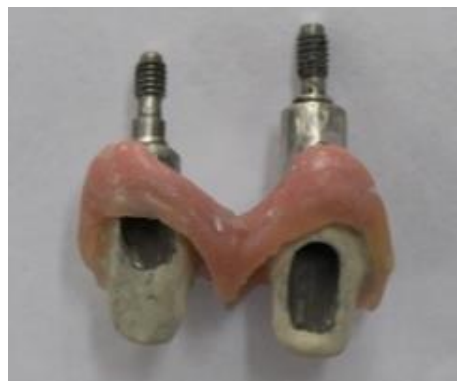
Fig. 9: Ceramic soft tissue moulage on the titanium framework

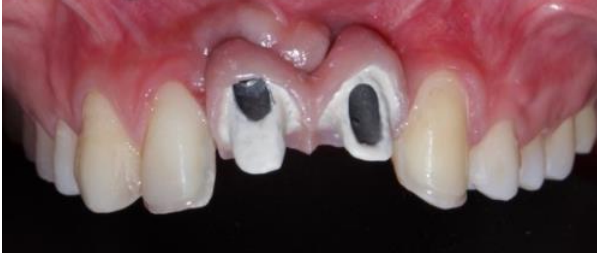
**Fig. 10:** Laminate preparation on 12, 23 and trial insertion of screw-retained framework

Laminate preparation on 12 and 23 was done using Gurel’s technique to ensure a conservative preparation and a final impression of the prepared teeth along with the titanium framework was made in polyether impression material (Impregum; 3M ESPE).

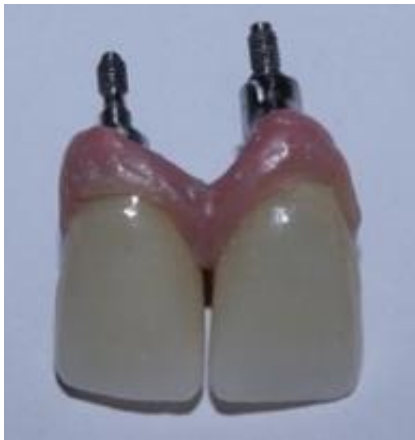
**Fig. 11:** Definitive prosthesis

Thereafter, the ceramic of the various parts of the definitive prosthesis were glazed. The abutment screws were tightened to a torque of 30N, followed by blockage of the screw-access hole with gutta percha and composite resin.

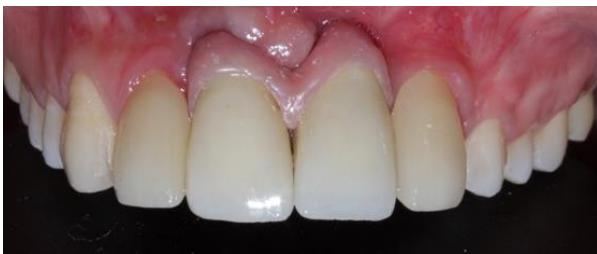
**Fig. 12:** Intra-oral view of definitive Paulo Malo prosthesis and laminate veneers

The zirconia crowns were cemented with a resin reinforced glass ionomer cement (Fuji Cem, GC) and the laminates with a resin cement (Calibra).
