Rehabilitation of a patient with severely attrited dentition– A case report

Abstract

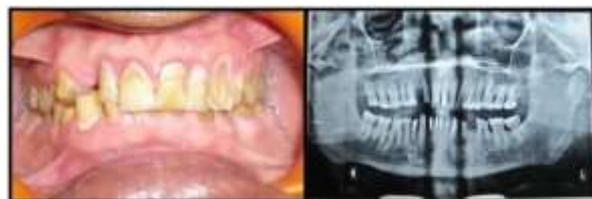
moderate loss of vertical dimension. Bilaterally, molar and canine relationship was class I. The patient demonstrated a slide from centric relation to maximum intercuspation position. There was generalized discoloration of the whole dentition with fair oral hygiene. There was an alteration in occlusal plane with unaesthetic appearance of teeth, and patient had no sign of pocket and bone loss. 13 and 35 were missing and 43 was supraerupted. Radiographic examination revealed generalized severe attrition and endodontic treatment w.r.t 21, 31, 32, 33, 34, 41, 42, 44 with adequate bone support (Fig. 1).

Fig. 1: Pre-operative intra oral view and OPG

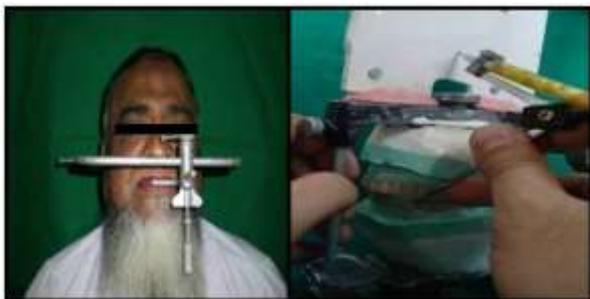
Broadrig's Flag Method (Fig. 2).⁽⁶⁾ Diagnostic mounting was done at increased vertical dimension using occlusal splint(Fig. 3)

Fig. 2: Face bow transfer and determination of occlusal plane with Broadrig's flag method

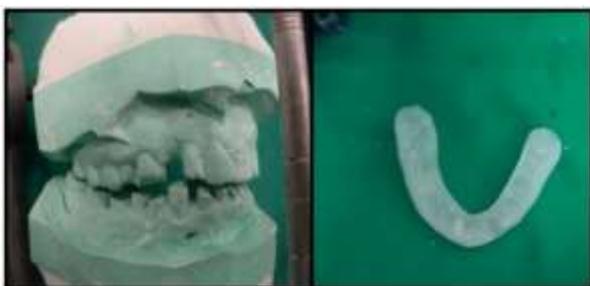
Fig. 3: Diagnostic mounting at increased vertical dimension using occlusal splint

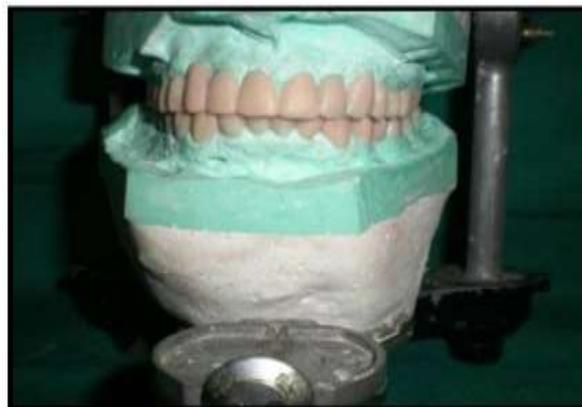
Fig. 4: Completed diagnostic wax-up

- Following this, diagnostic wax-up was done at the established new vertical to check the outcomes (Fig. 4). Diagnostic wax-up was carried out keeping in mind the anterior guidance, existing occlusal scheme, vertical dimension and mutilated dentition.^(7,8) Then an occlusal splint was provided to the patient as part of reversible interventional modalities to evaluate adaptation of the patient to altered VDO. The patient was kept on diagnostic and observational period of 6 weeks before the definitive restorative phase of rehabilitation was started.⁽⁹⁾ The teeth were prepared and Stage I provisional restorations were fabricated chairside, segment by segment during several appointments to minimize patient discomfort and efficiently use the appointment time. The patient's vertical dimension of occlusion was maintained by using unprepared teeth as occlusal vertical stops. Minimal occlusal reduction is generally indicated for patients scheduled for rehabilitation at an altered vertical dimension of occlusion. The definitive phase for full coverage metal–ceramic tooth preparations was completed for the entire dentition with minimal occlusal reduction and final elastomeric impression were made (Fig. 5); Stage II provisionals were fabricated using the putty index of the diagnostic wax-up and cemented with noneugenol ZnO cement (Fig. 6). The final impressions were poured and the

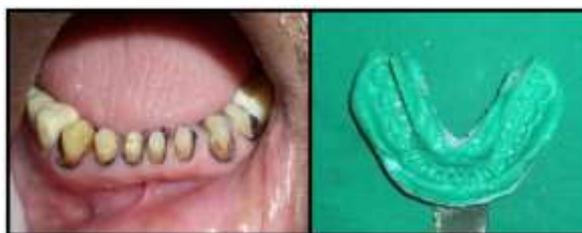
Fig. 5: Tooth preparations and final impression

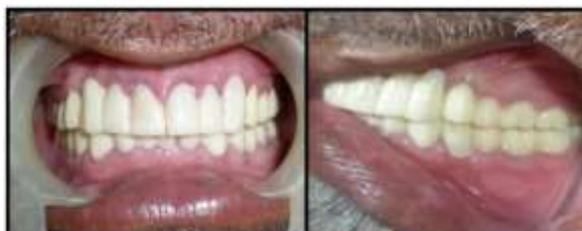
Fig. 6: Provisional restorations: frontal and lateral view

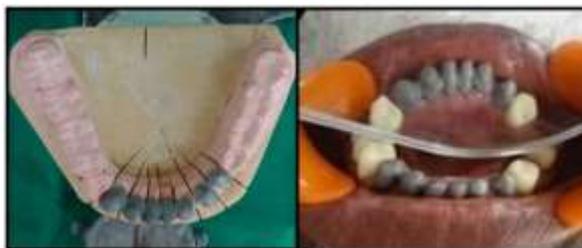
Fig. 7: Metal try in

The casts were then die cut and wax patterns were fabricated and casted. Following which all metal copings were tried intraorally to evaluate internal fit and stability (Fig. 7). Definite restorations with PFM crowns exhibiting a vital and natural appearance with proper contour, shade and optimal incisal translucency were fabricated (Fig. 8, 9). Permanent cementation was done with GIC type I luting cement.

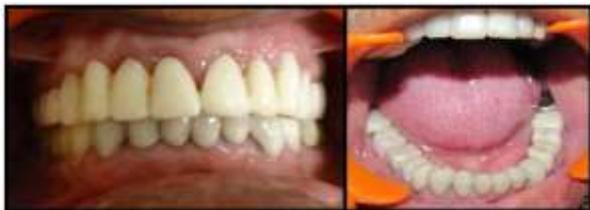
Fig. 8: Post op- intraoral: frontal and occlusal view

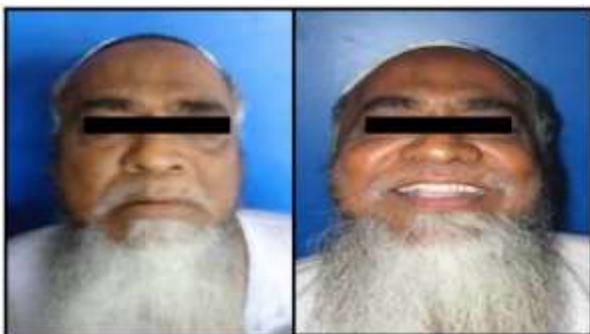
Fig. 10: Extra oral: Pre and Post- op view

Outcome and follow up: Oral hygiene instructions were given, emphasizing on brushing habits and the use of floss threaders and dental floss. Follow-up was carried out at regular intervals and the patient's post-operative condition was found satisfactory. The patient pre and post operative views are shown in Fig. 10.
